Manhole Inspection Summary

Manhole # S170__016MH

Location Address: **2601 wilkens av**

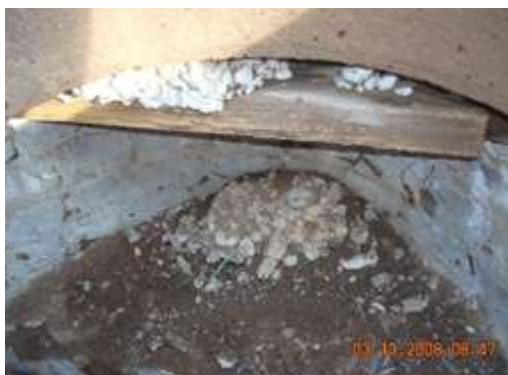
Misc. Defect 1

wood backing to concrete repair from side walk pour

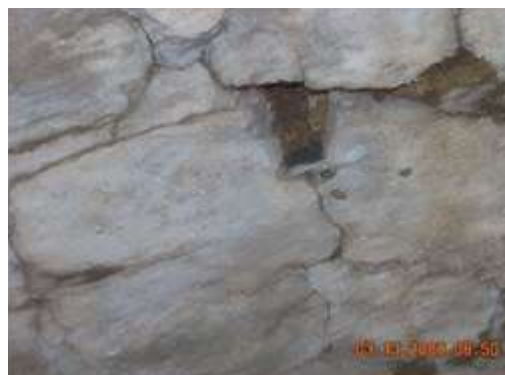
Defect 3

Condition: ☐ Sound ☒ **Cracked** ☐ Root Intrusion ☐ Loose Brick ☐ Deteriorated

cracked and missing mortar

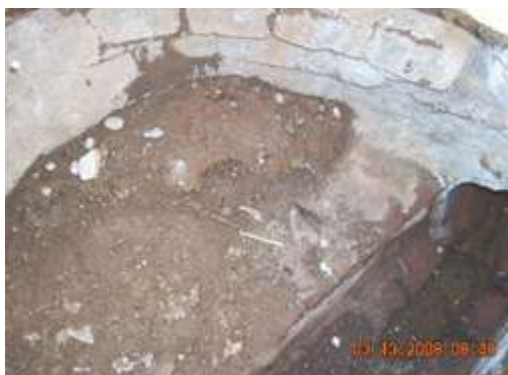
Defect 2

Condition: ☐ Sound ☐ Cracked ☐ Root Intrusion ☐ Deteriorated ☐ Leaks ☒ **Debris**

debris on bench

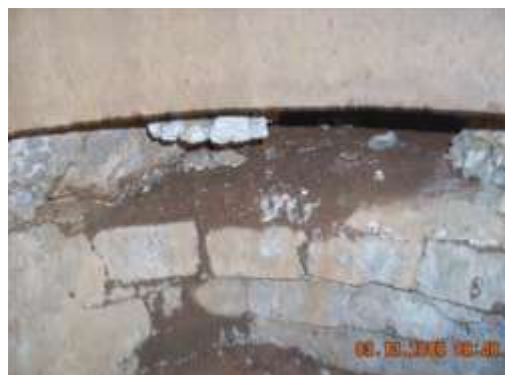
Defect 4

Condition: ☐ Sound ☐ Cracked ☐ Root Intrusion ☐ Loose Brick ☒ **Deteriorated**

missing bricks from deteriorated chimney

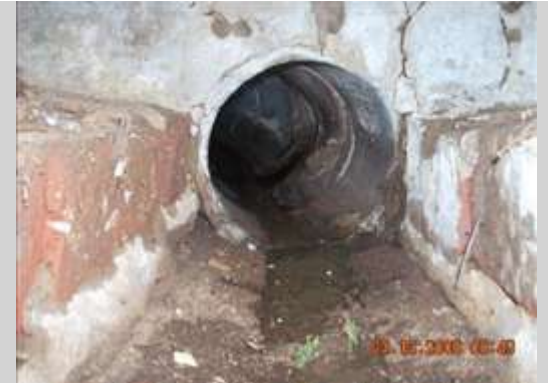
12 O'Clock Outflow

8 in. Circular Gravity Sewer
Pipe Out @ 12 O'Clock

Infiltration: **None** Pipe Seal Cond: **Cracked**

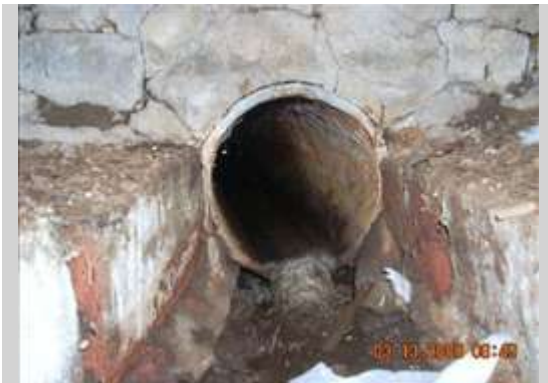
6 O'Clock Inflow

6 in. Circular Gravity Sewer
Pipe In @ 6 O'Clock

Infiltration: **None** Pipe Seal Cond: **Cracked**
